## O&M INSPECTION REPORT FOR NAVIGATION PROJECTS

MANELE SMALL BOAT HARBOR

1. Project Name: Manele SBH
2. Date of Inspection: June 10, 2005

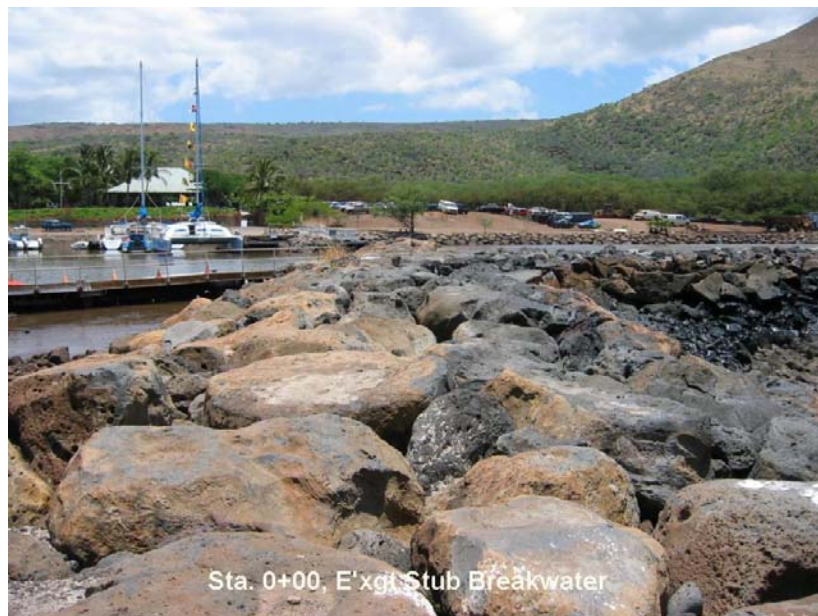
- a. Overview at start of the existing Stub Breakwater from trunk to root. Ocean side is to the right, and harbor side is to the left.

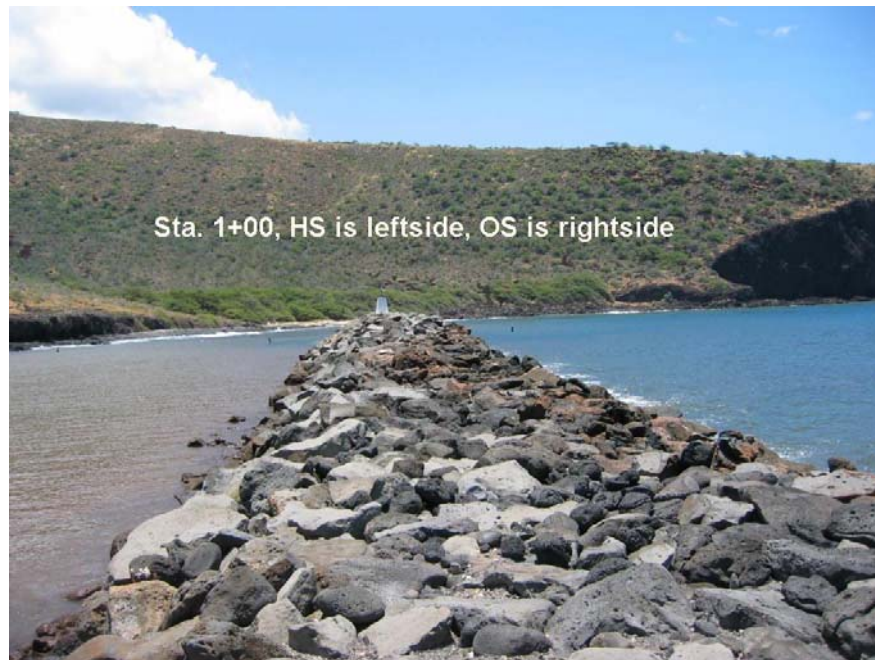
b. Overview at end of project from trunk to head. Ocean side is to the right, and harbor side is to the left.

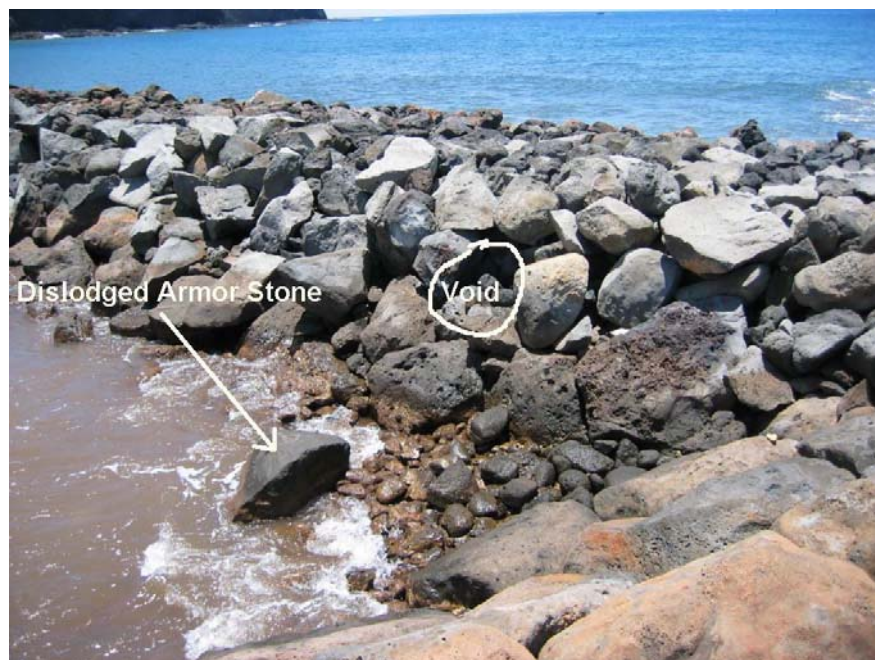
c. Sta. 1+09, HS, dislodged armor stone 3' from toe. Void is half way up side slope.

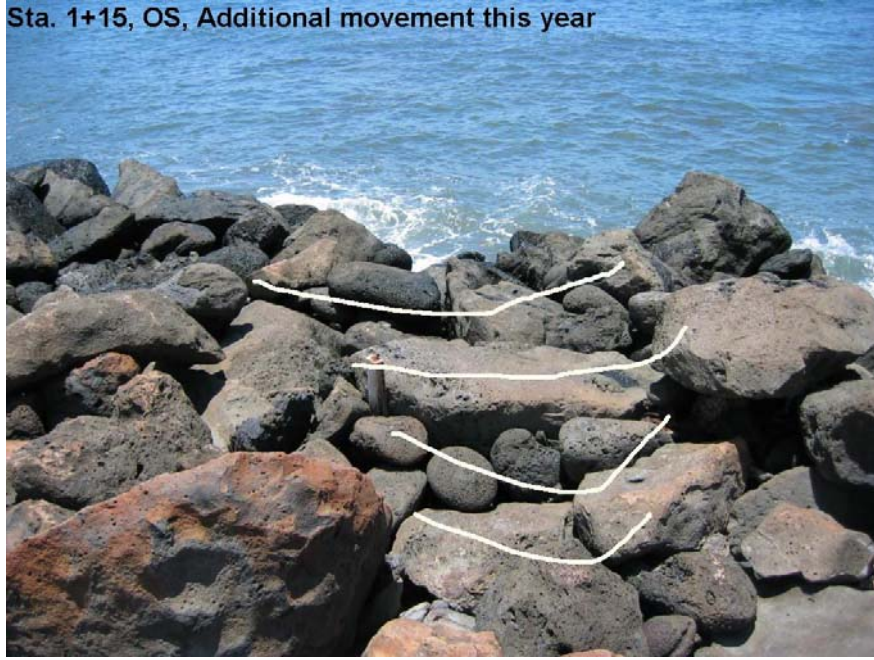
Sta. 1+15, OS, Additional movement this year

d. Sta. 1+15, OS, dislodged armor stone w/ voids, lower sideslope failure. Additional settling at sideslope new this year.

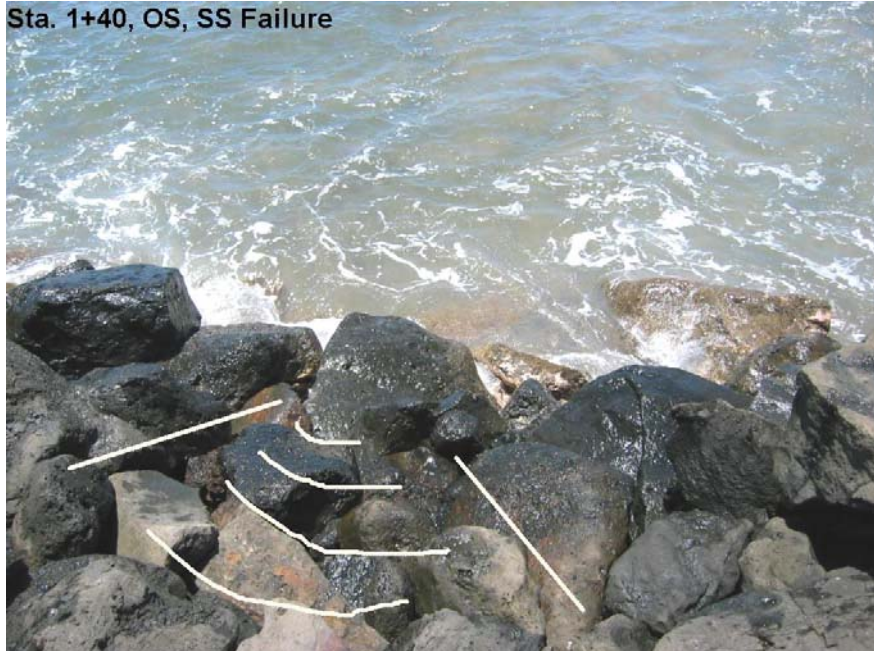
Sta. 1+40, OS, SS Failure

e. Sta. 1+40, OS, sideslope failure. 8 LF hinge to toe under layer exposed.

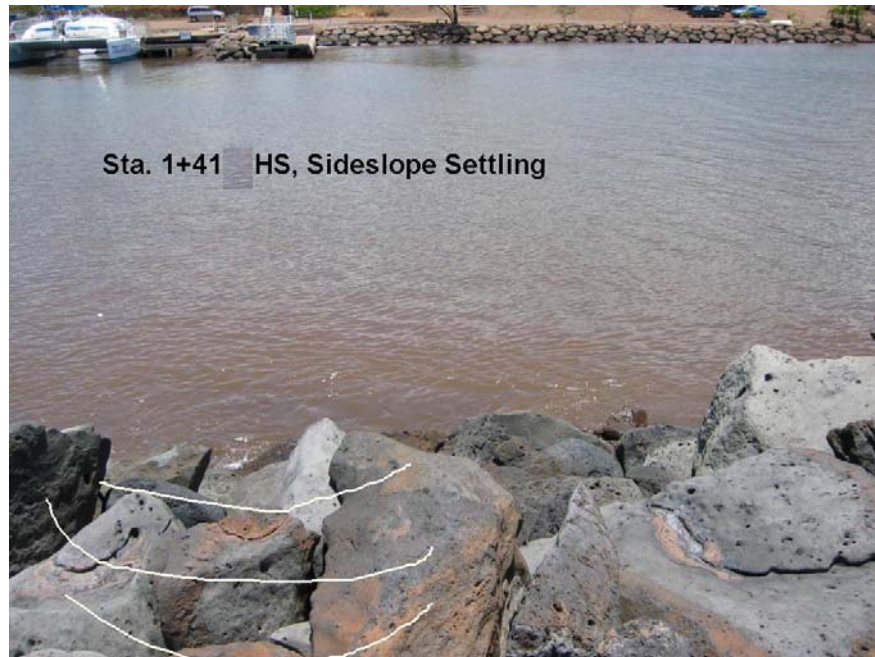
f. Sta. 1+41, HS, Sideslope settling, new this year.

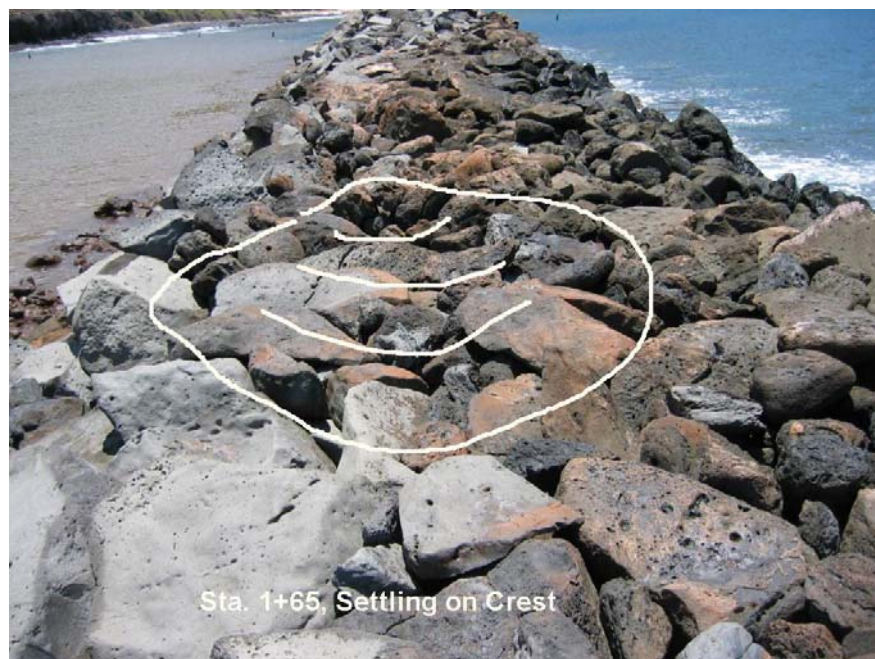
g. Sta. 1+65, Crest settling, new this year.

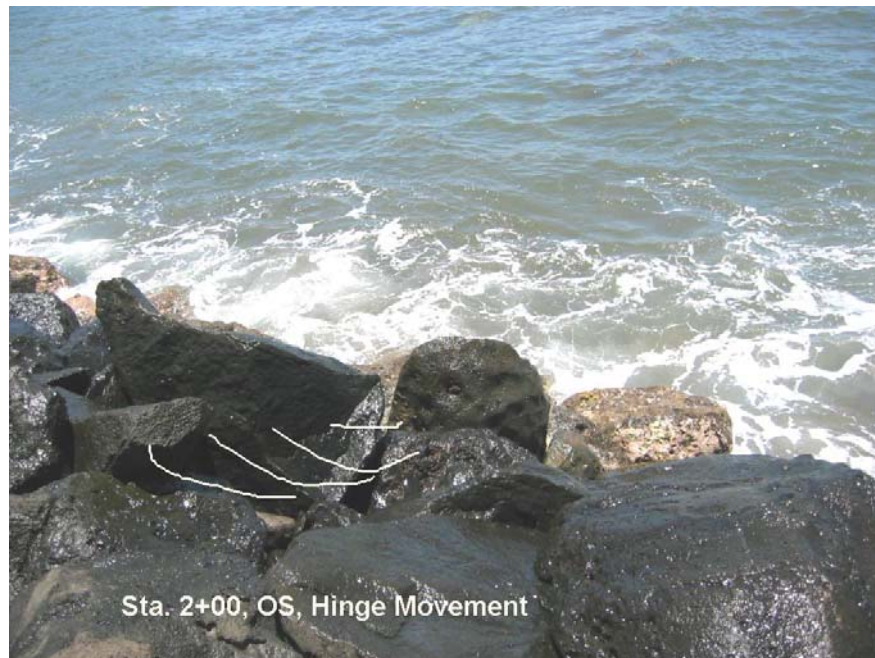
- h. Sta. 2+00, Hinge movement, new this year. Reference wooden stake.

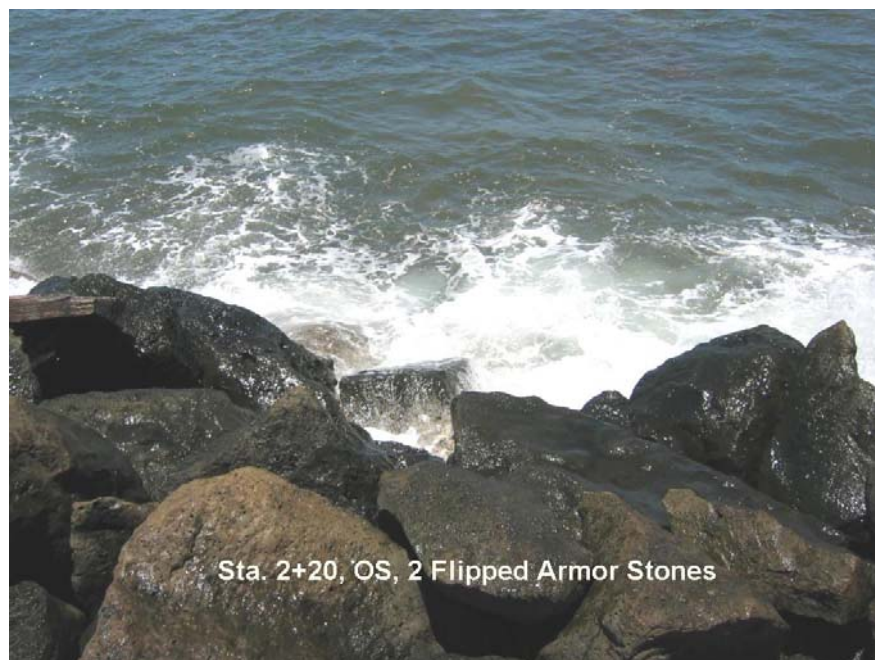
- i. Sta. 2+20, OS, 2 flipped armor stones on side slope.

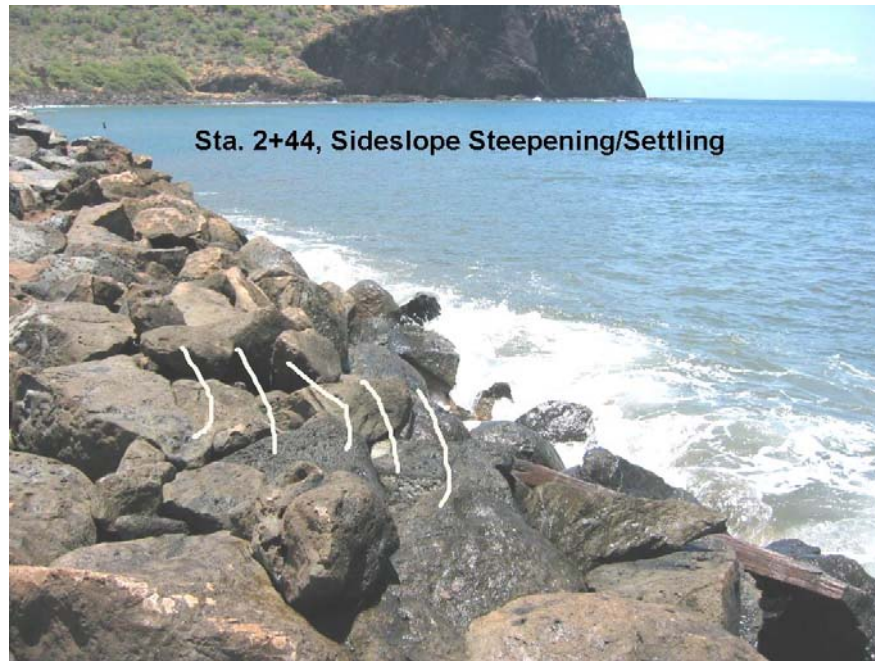
j. Sta. 2+44, OS, side slope steepening. Void under side slope. Under layer not exposed. (Adjacent white cross)

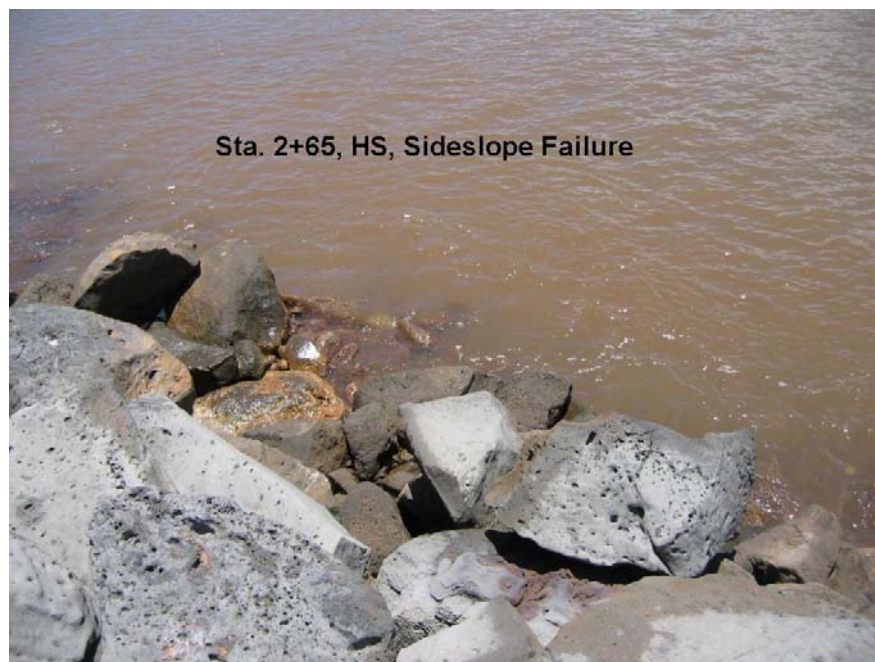
- k. Sta. 2+65, Previous inspection was void at crest, new deficiencies is OS, sideslope failure.

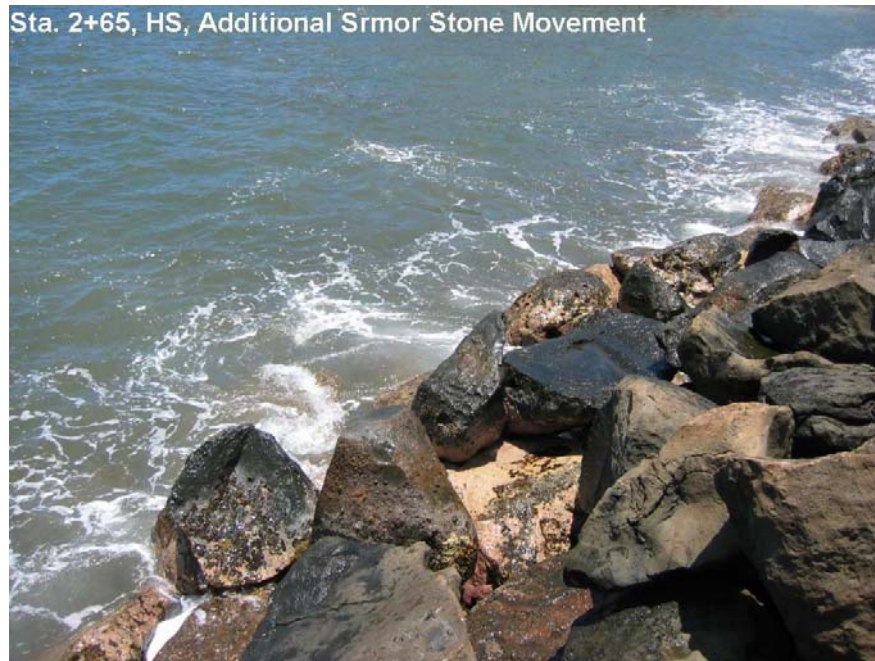
- l. Sta. 2+65, HS, dislocated armor stones from sideslope, additional movement this inspection.

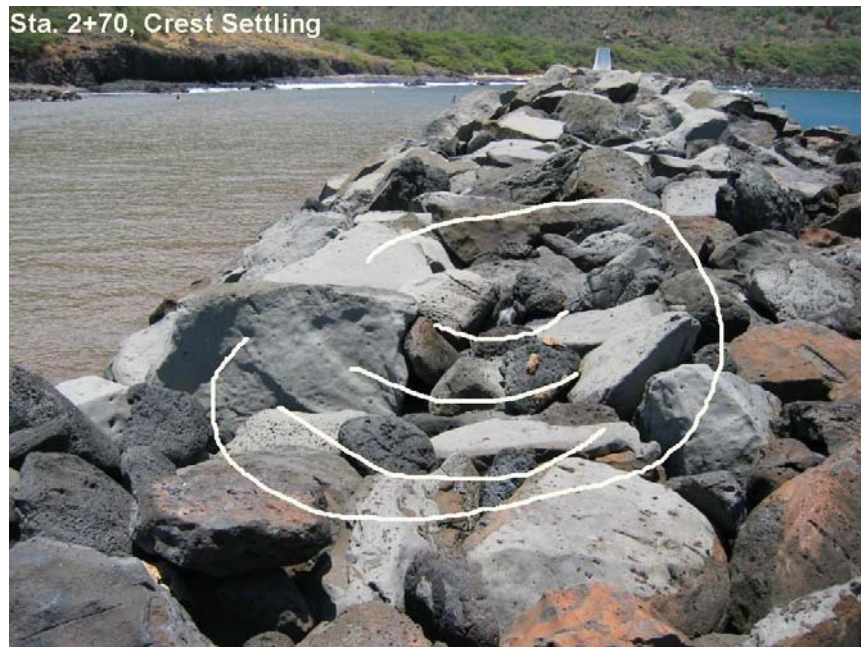
- m. Sta. 2+70, Crest settling, new this year.

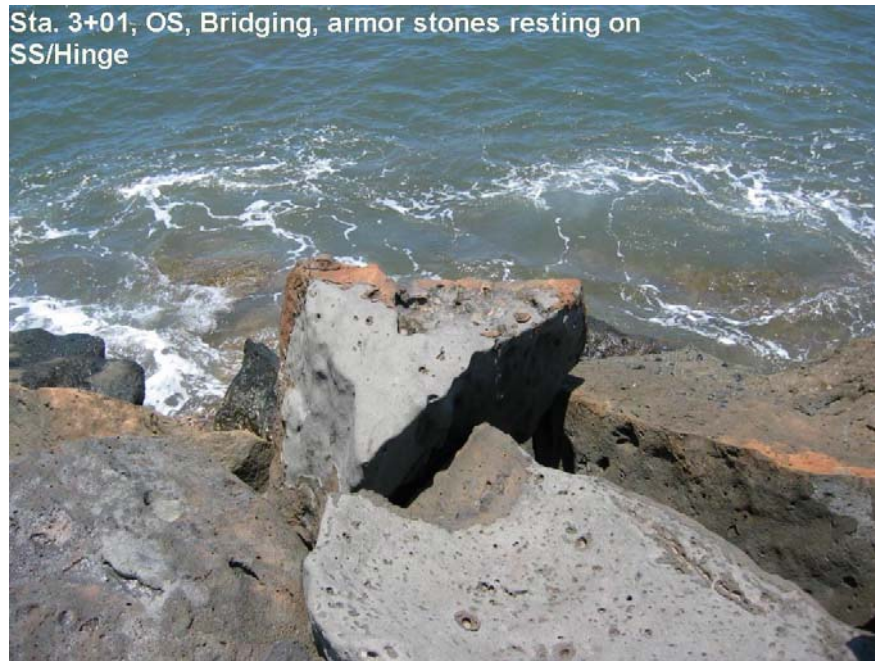
- n. Sta. 3+01, OS, 1 armor stone resting at hinge, bridging.

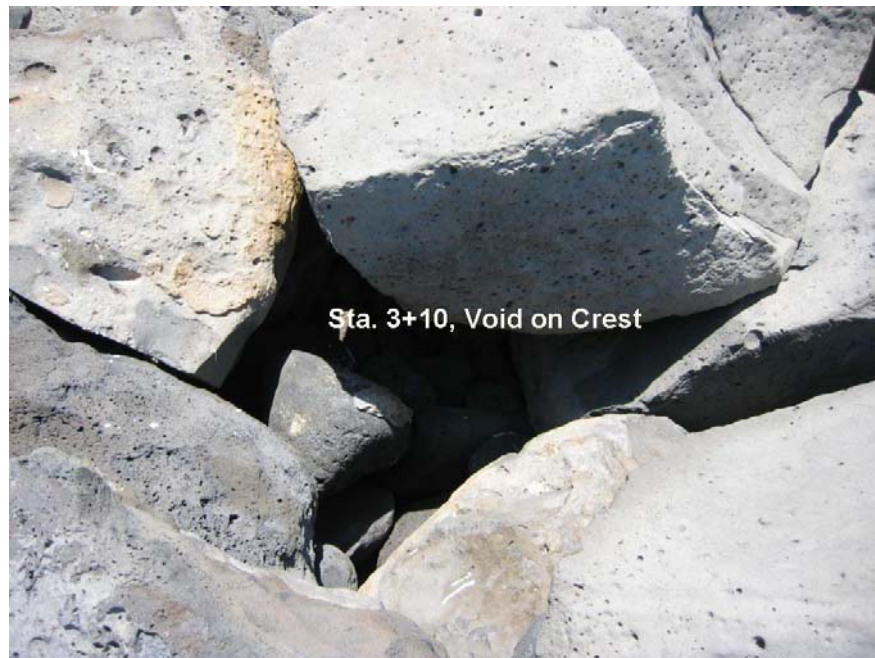
- o. Sta. 3+10, Void centerline of crest, new this inspection, adjacent white cross.

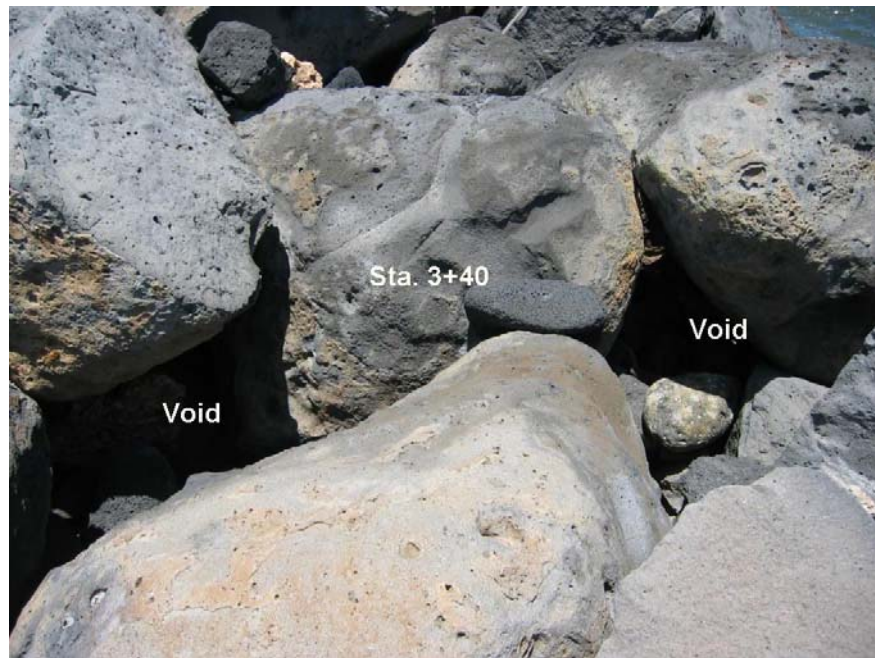
p. Sta. 3+40, 2 large voids at center line of crest. No Change.

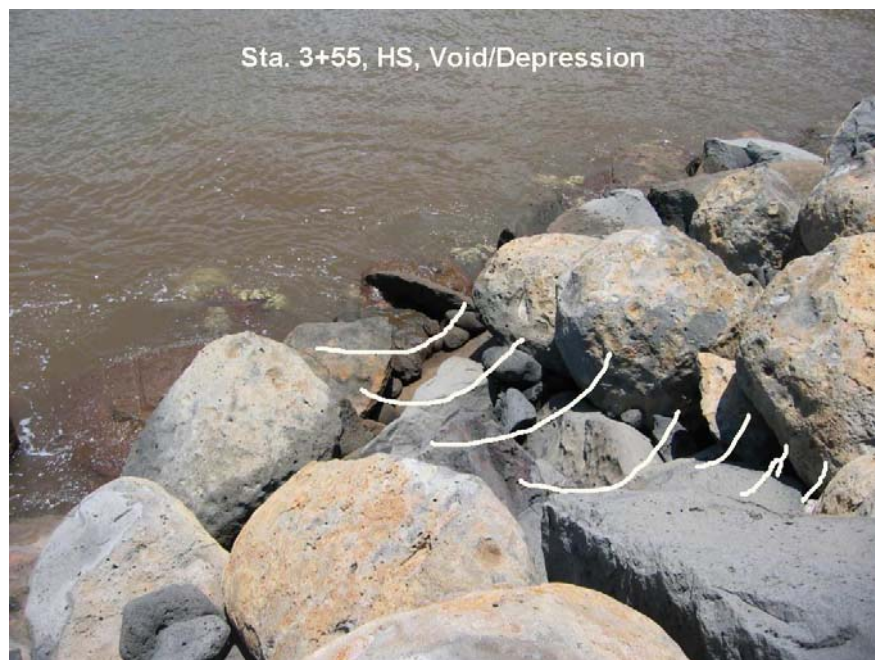
q. Sta. 3+55, HS, Large void/depression on sideslope.

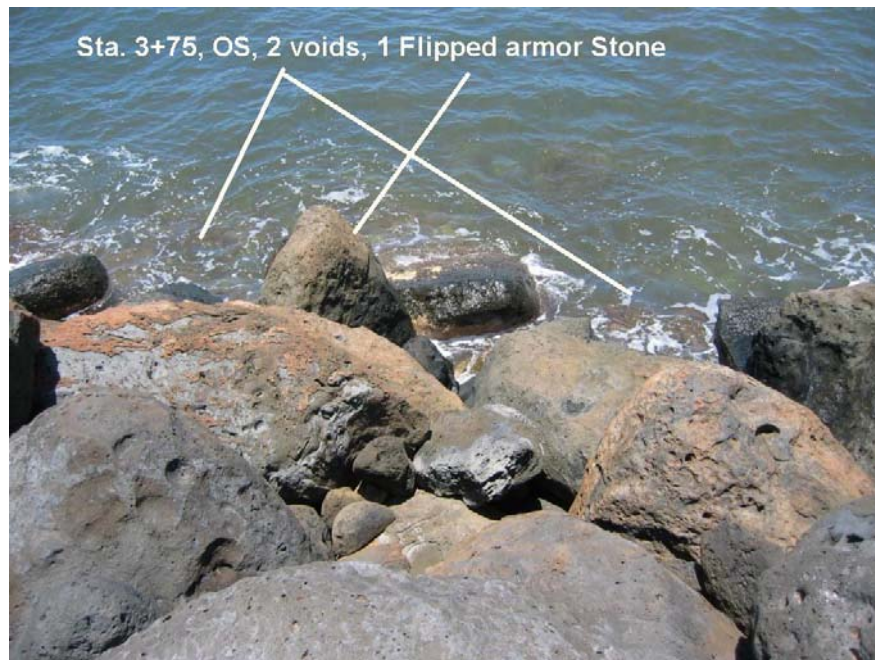
r. Sta. 3+75, OS, 2 voids, 1 flipped armor stone.

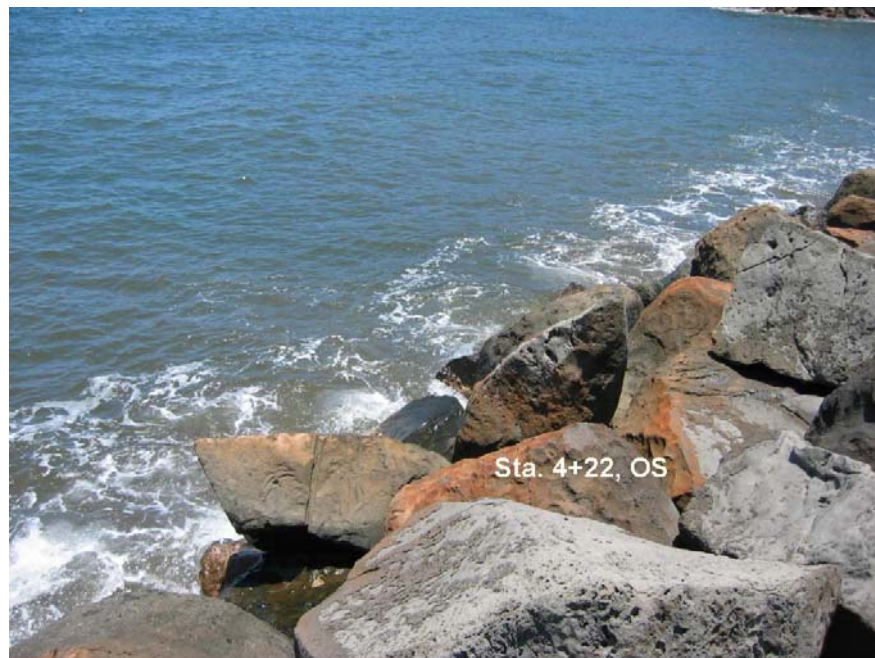
t. Sta. 4+22, OS, 1 armor stone dislodged resting on side slope, 1 fractured armor stone, void at waterline.

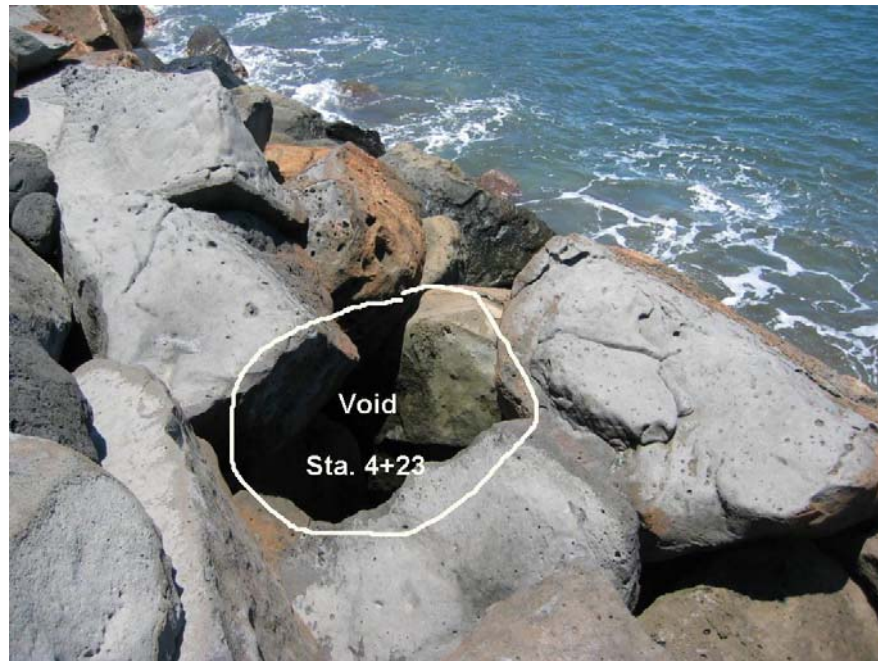
u. Sta. 4+23, OS, hinge, void.

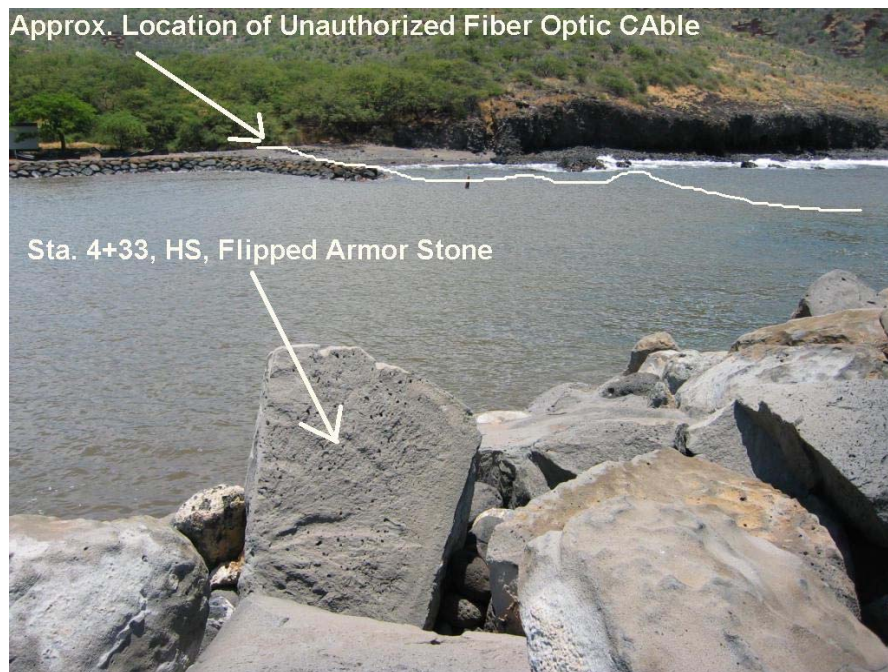
v. Sta. 4+33, HS, flipped armor stone.

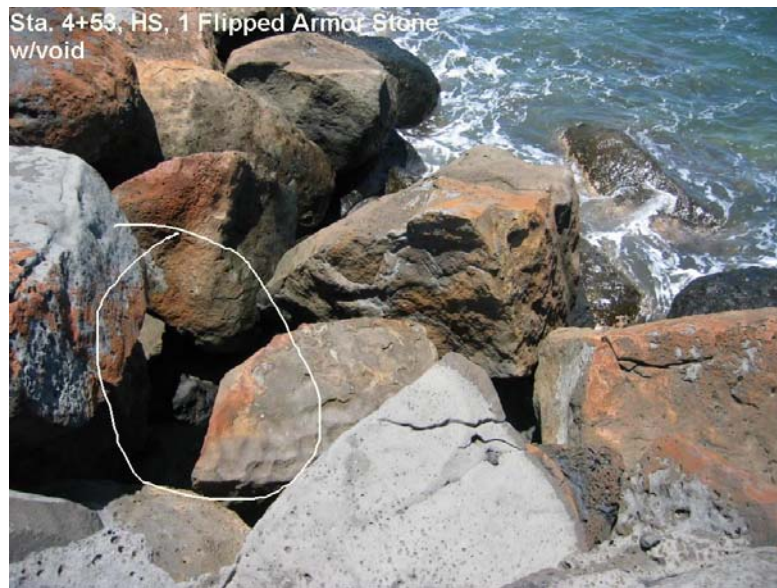
w. Sta. 4+53, HS, sideslope, 1 ea. Flipped armor stone w/void. New.

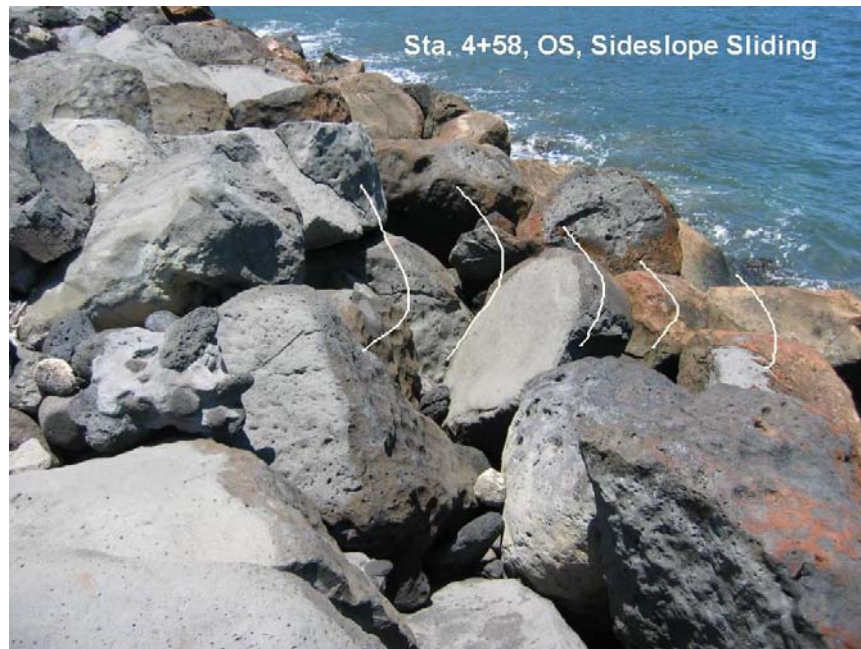
x. Sta. 4+58, OS, sideslope settling, new this year.

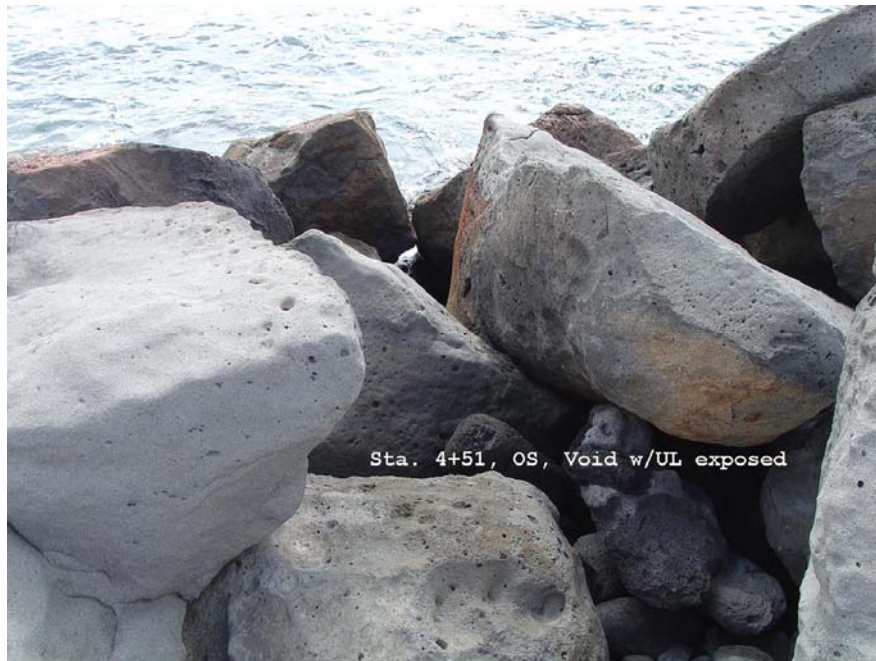
y. Sta. 4+51, OS, large void with exposed under layer. Dislocated armor stone is resting on side slope, which is also steepening.

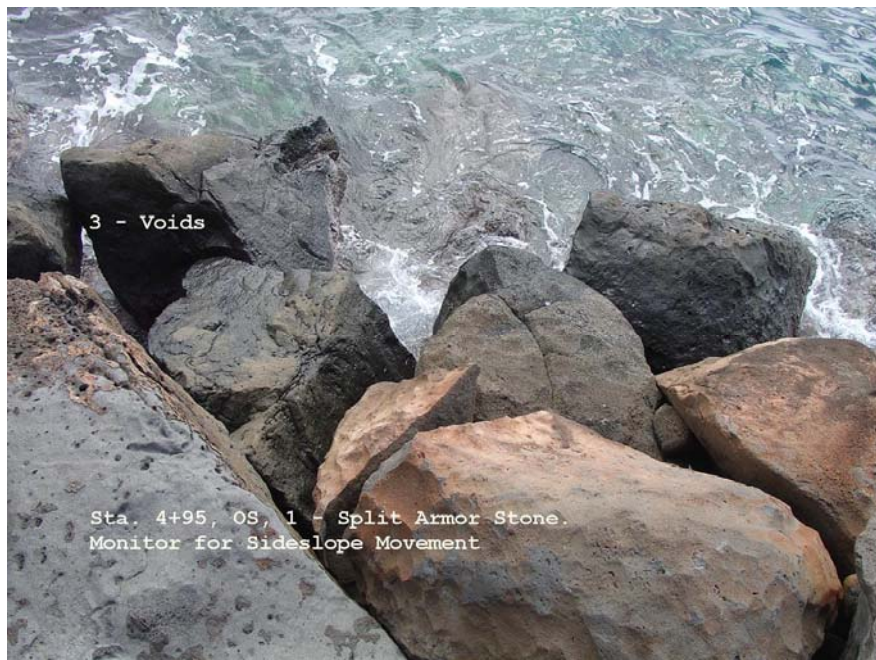
z. Sta. 4+95, OS, sideslope movement, 1 - split armor stone. FY 04 Photo.

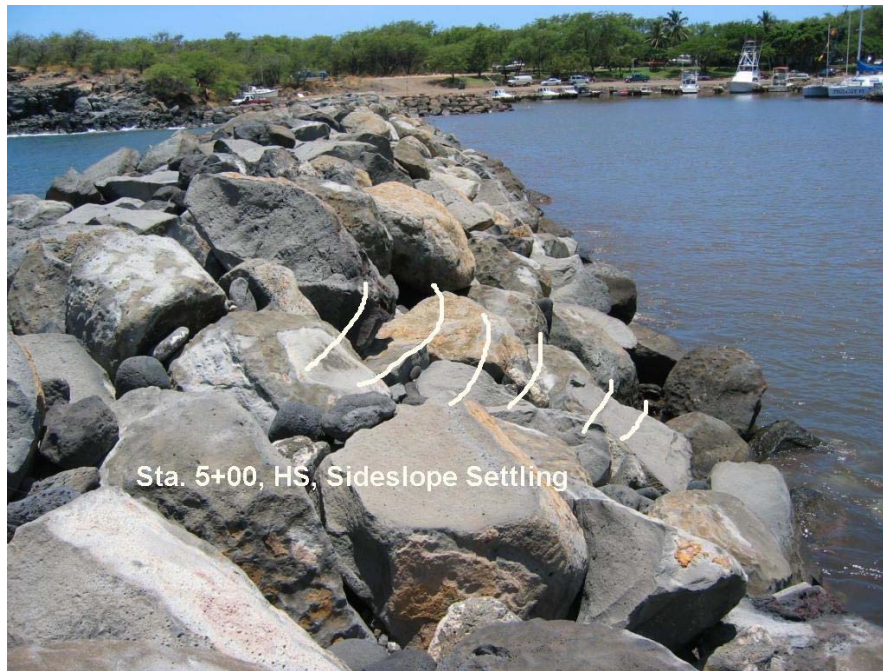
aa. Sta. 5+00, HS, sideslope settling.

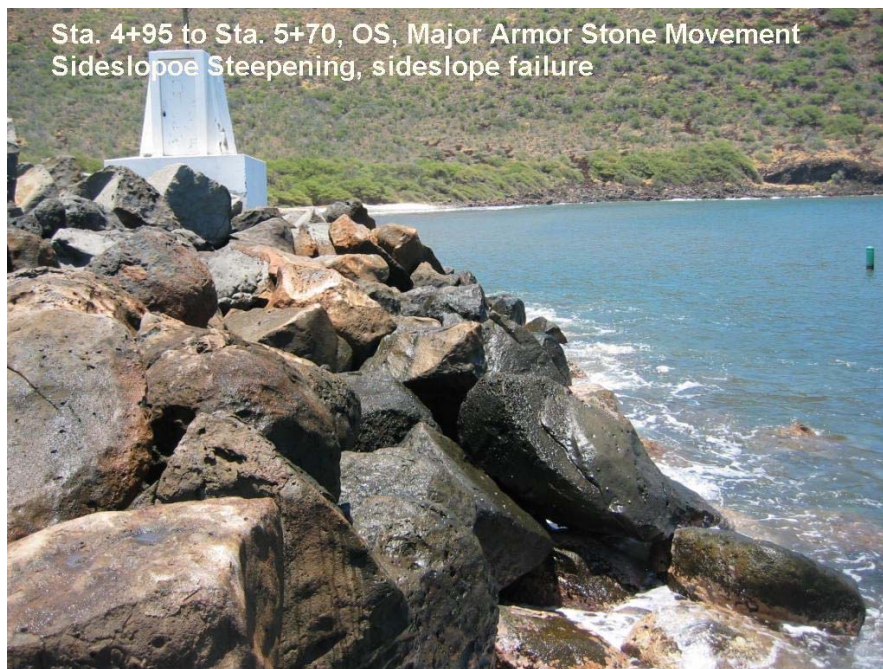
New deficiencies were noted on this inspection and are indicated. The Oceanside (OS) of the structure at Sta. 4+95 thru Sta. 5+70 has dramatic changes this inspection and has deteriorated drastically.

bb. Sta. 4+95 - Sta. 5+70, OS, major armor stone movement, sideslope, settling, sideslope failure.

After review of the past O&M inspections it appears the project was constructed with "extreme" randomness with respect to the armor stone placement and the noted items, while not the result of wave energy, are being exacerbated by wave action. The armor stones are not keyed and fitted resulting in loose and undersized which cause rocking. The lack of interlocking stones has created large voids, bridging, perched rocks, and exposed under layers and cores to direct wave action. The past photos reveal a steady decline in the contact of the armor stones. There has been a significant change in Sta. 4+95 to Sta. 5+70, OS, this year. An additional inspection should be conducted.

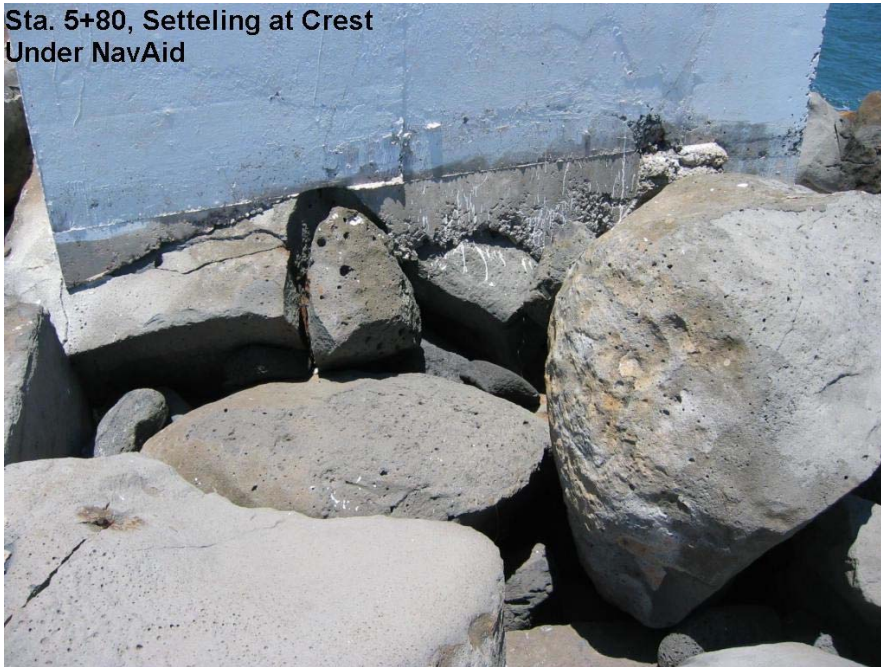
Sta. 5+80, Settling at Crest  
Under NavAid

cc. Sta 5+80, additional crest settling under NavAid foundation this year.

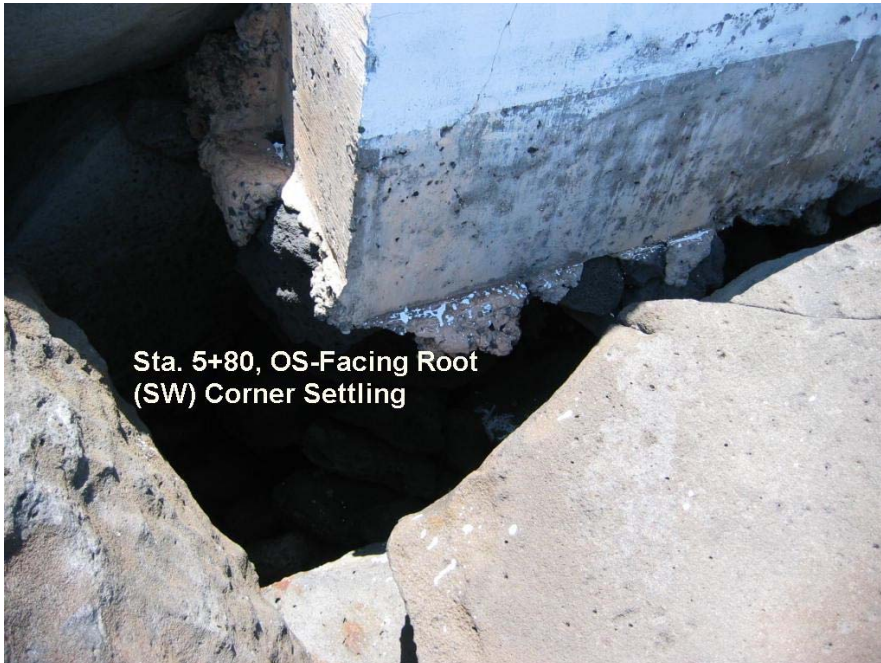
Sta. 5+80, OS-Facing Root  
(SW) Corner Settling

dd. Sta. 5+80, OS, Southwest corner of foundation. BW settling.

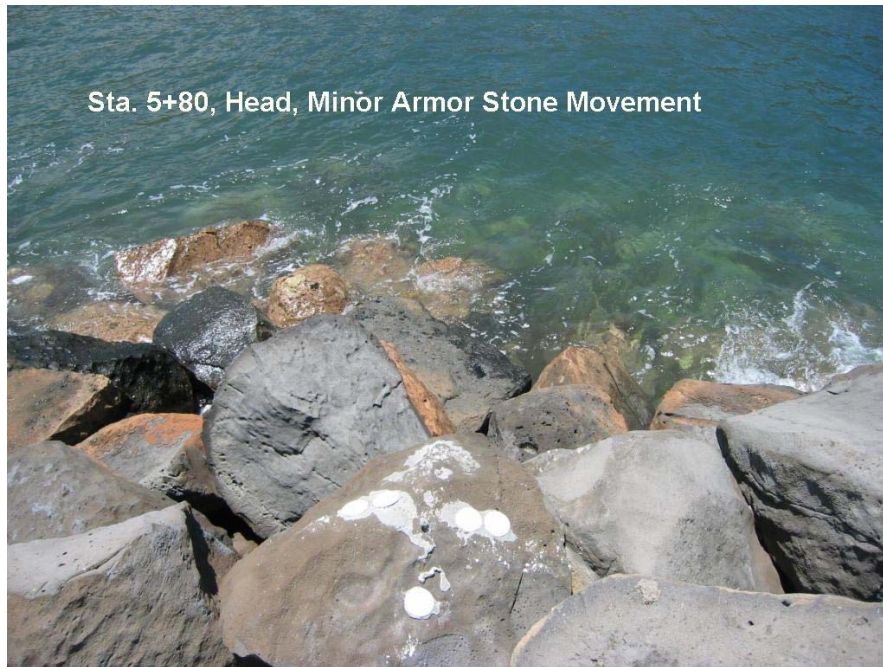
ee. Sta. 5+87, picture taken from 22 degrees HS to 22degrees OS at the head of the structure. There is a possibility of a missing layer of armor stones at water line.

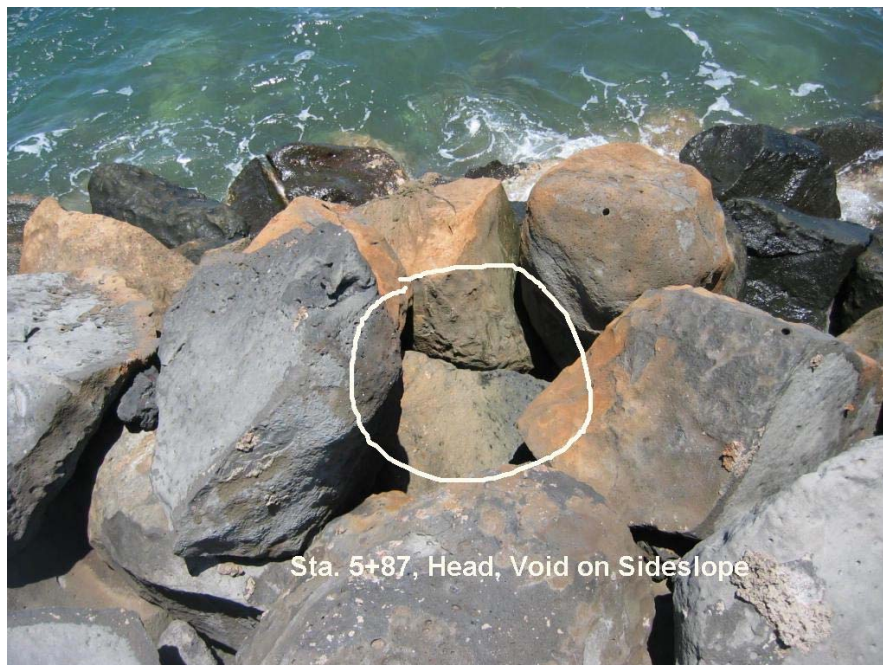
ff. Sta. 5+87, picture taken from top of monument at 20 degrees HS to centerline of head at 0 degrees. There is a possibility of a missing layer of armor stones at water line.

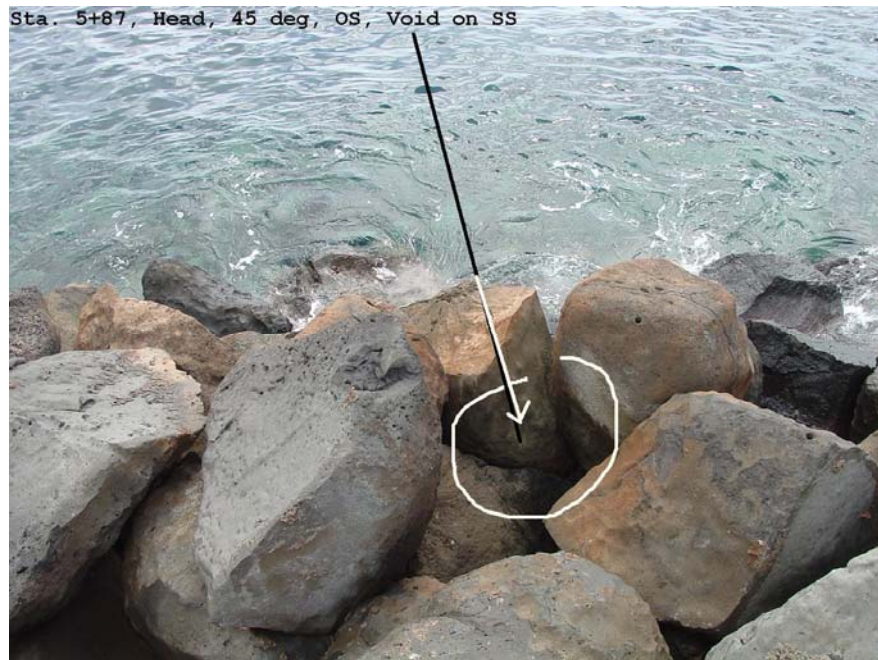
gg. Sta. 5+87, picture taken from top of monument at center line of head at 0 degrees to 22 degrees OS. There is a possibility of a missing layer of armor stones at water line.
